# Bellamar

Punta Mita Living

## Sea Wall Repairs

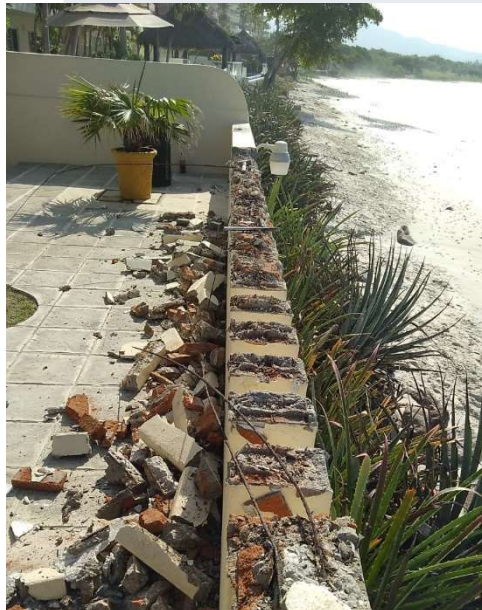
Some of you may have noticed that our sea wall had quite a number of cracks in it. Ivan and his crew were hired to do a special project this year and do repairs. We had hoped that we would find that the cracks were superficial.

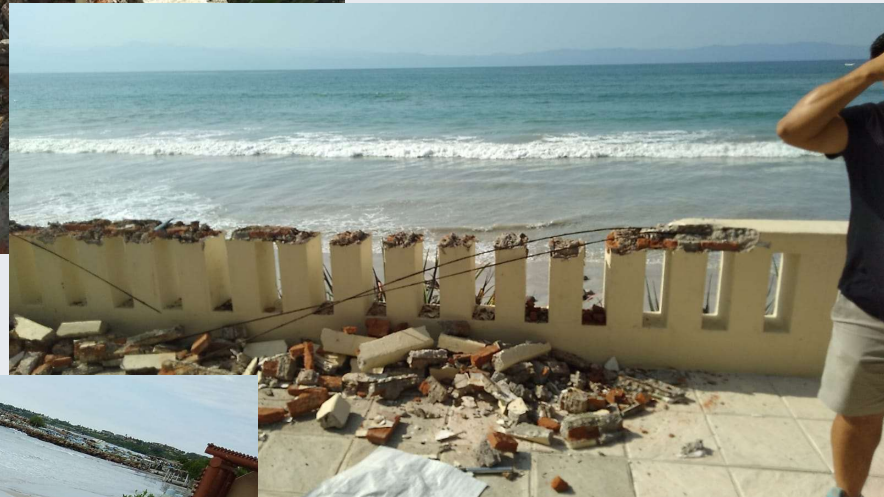
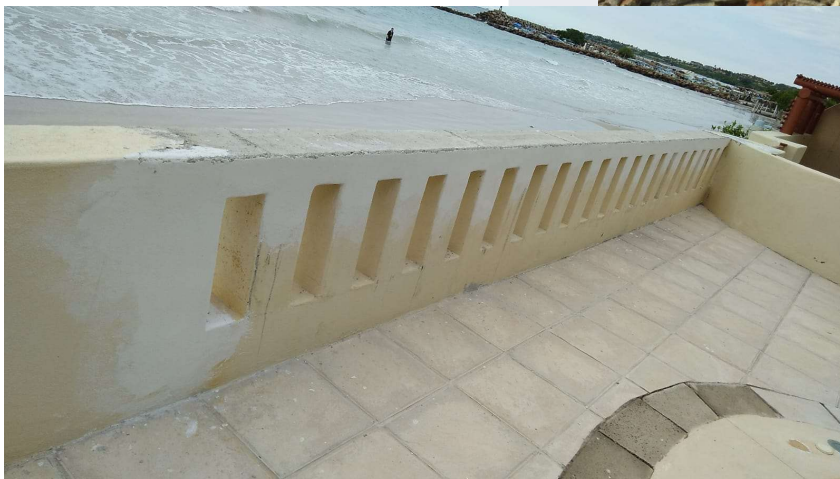
Alas, what we discovered upon starting to chip away the top layer of cement was that water had worked its way down to the rebar. So we had to remove the whole top layer, remove the rusted rebar and rebuild the top portion of the wall. It was rebuilt using a type of cement that is a bit more "rubbery".

It has some movement in it - which hopefully will mean that when the wall vibrates due to the pounding of the surf that the cracks will not reform. All it needs now is a coat of paint!

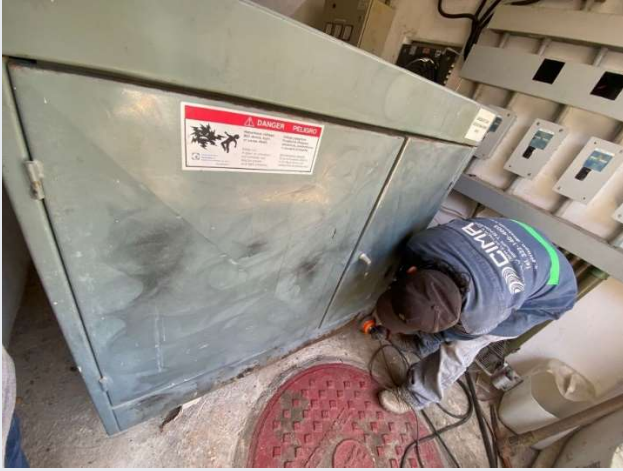
The Bellamar transformer hadn't gotten maintenance since 2018. It was looking pretty ratty.

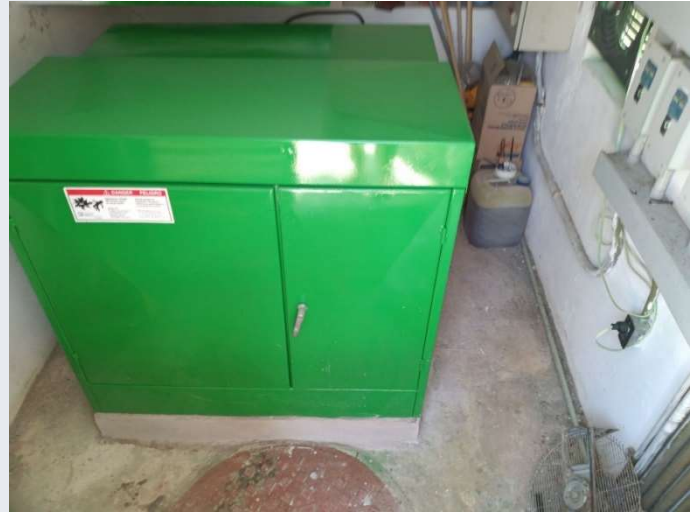
As you can see from the photo below, it looks brand new now! We also had it raised up about 4 inches so that when water gets into the room, the transformer is not sitting in the water. While you might wonder why we would bother to paint it, that's actually an important part of maintaining it to ensure that the cabinet does not rust. Additionally, if it overheats, the paint starts to bubble letting you know that something is wrong.

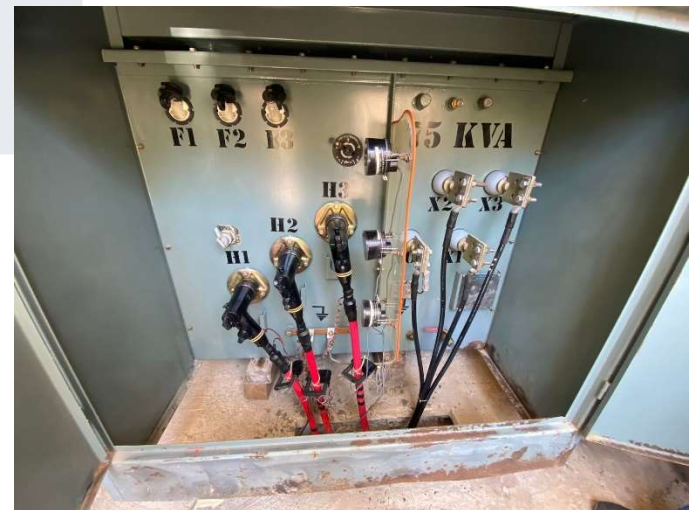
The transformer tech recommended we stop storing our trash in with the transformer for two reasons (1) good air circulation around the transformer is critical to maintaining a long life so it stays cool, and (2) because it encourages mice and rats to live near the transformer - and those little guys love to chew on the wires.

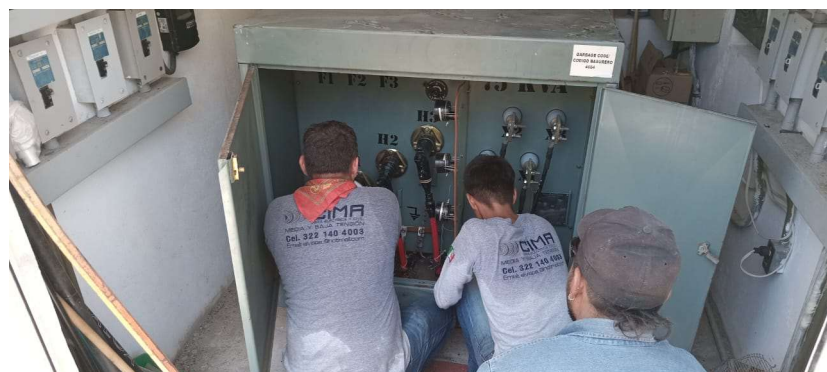
Once the transformer maintenance was completed, we could immediately tell its generating way less heat. That's great because we would love to see this transformer last another 10 years. The new exhaust fan we installed is also helping to ensure the unit stays cool.
